# Drainage Report

Site  
**24 Albemarle Terrace**  
**Taunton**  
**Somerset**  
**XX0 0XX**

## 24 Albemarle Road - CCTV Survey Report : 17/07/18

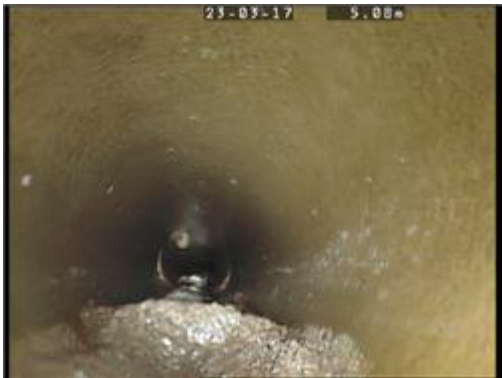
Pos	Code	Description	Image
00.00m	MH	Start node type, manhole MH F1	
00.00m	WL	Water level: 0% Height/Diameter	
05.10m	DES	Settled deposits fine: 20% Cross sectional area loss - Grade 2	Image Provided - Ref: 0_2

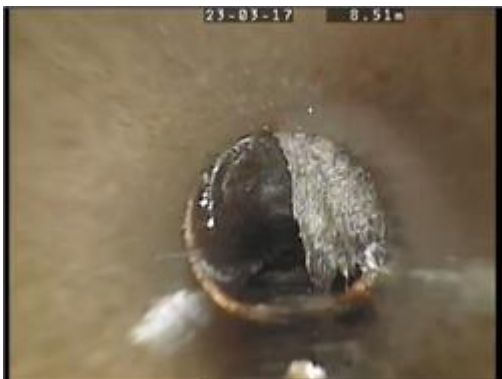
<b>Section: 1</b>  From: MH C1 To: MH C2	Mass Roots at 08.51m downstream of MHF1. We would recommend removal and prevention of further root growth. The drain is just serviceable.	<b>DRB Grade: B</b> <b>Pipe Size: 100</b> <b>Material: Vitrified Clay (i.e. all clayware)</b> <b>Use: Foul</b>
<b>Section: 2</b>  From: MH C2 To: G3	The JDL at 7.60m is likely to cause blockages. Our recommendation would be repair this defect by replacement. Patch lining the defect to smooth, if more cost effective, is another option.	<b>DRB Grade: C</b> <b>Pipe Size: 100</b> <b>Material: Vitrified Clay (i.e. all clayware)</b> <b>Use: Foul</b>
<b>Section: 3</b>  From: MH C2 To: MH C3	Grade A	<b>DRB Grade: A</b> <b>Pipe Size: 100</b> <b>Material: Vitrified Clay (i.e. all clayware)</b> <b>Use: Foul</b>

08.51m	RJ	Roots at joint - Grade 2 Mass 40%	Image Provided - Ref: 0_4

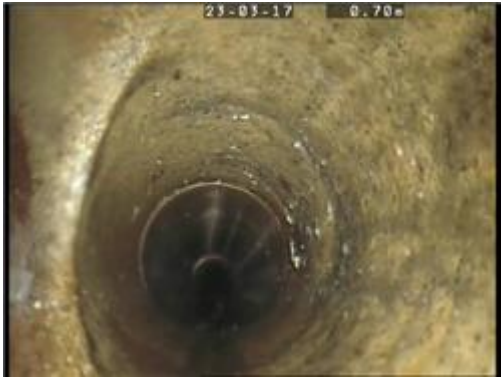
Pos	Code	Description	Image
00.00m	MH	Start node type, manhole F2	
00.00m	WL	Water level: 0% Height/Diameter	
01.06m	JN	Junction at 09 o'clock: 100mm Diameter	Image Provided - Ref: 1_2

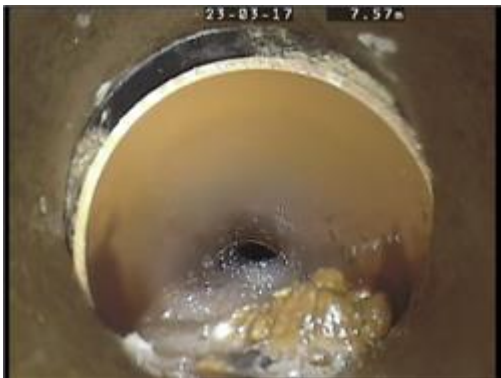
07.60m	MCPVC	Material of pipe changes to Polyvinyl Chloride	
07.60m	JDL	Joint displaced large - Grade 3 Causing blockage.	Image Provided - Ref: 1_4

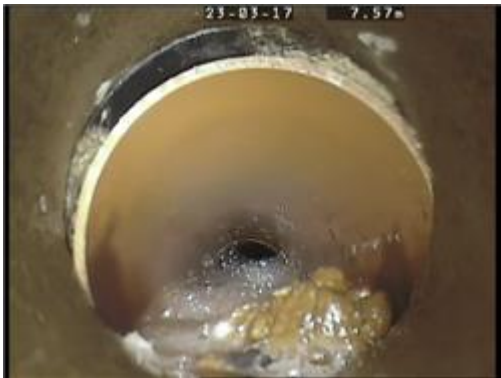
07.60m	OB	Other obstacles: 15% Cross sectional area loss - Grade 3 Partial blockage due to displacement.	Image Provided - Ref: 1_5

07.60m	SA	Survey abandoned Unable to pass safely.
